Confidential Inspection Report

LOCATED AT:
Sample Street
San Francisco, California 94112

INSPECTED ON:
Thursday, August 5, 2021

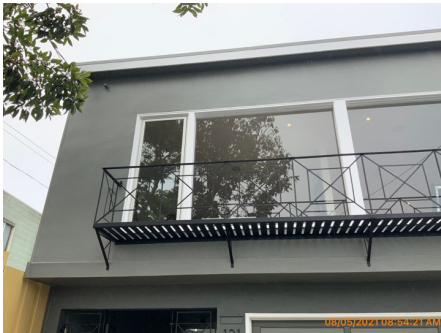
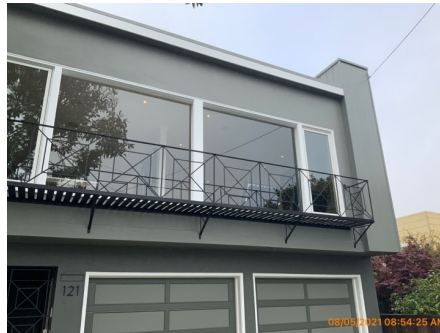
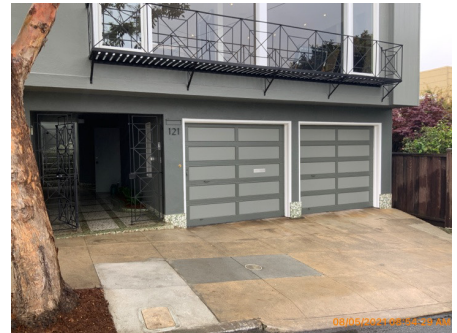
SURFACES STUCCO

- 17:** The stucco exterior is generally in serviceable condition.

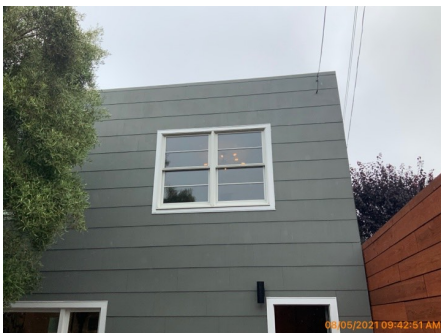
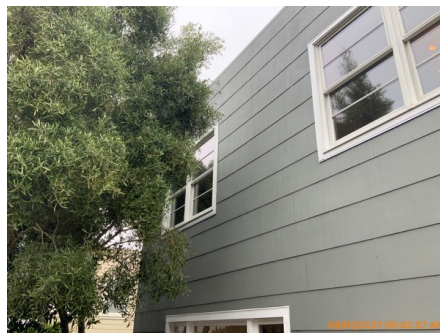
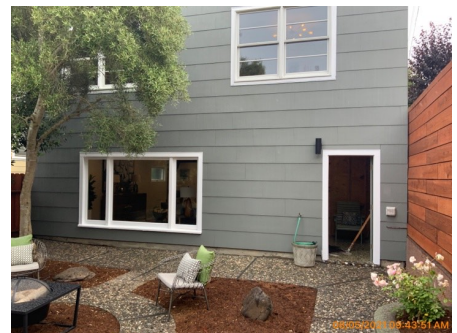
SURFACES SHINGLES

- 18:** The shingle siding on this building is a cement asbestos or 'Transite' material. It is a durable but brittle material and replacement shingles will be difficult to locate. The shingles are generally in good condition in this case.

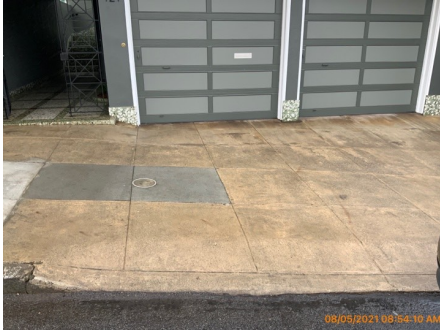
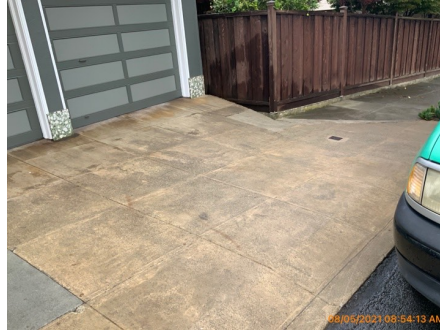
IMPROVEMENTS DRIVEWAY

23: The driveway appears to be properly installed and is generally in good condition.

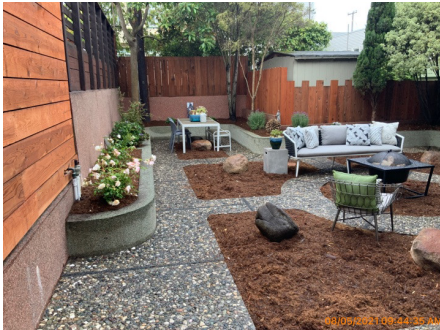
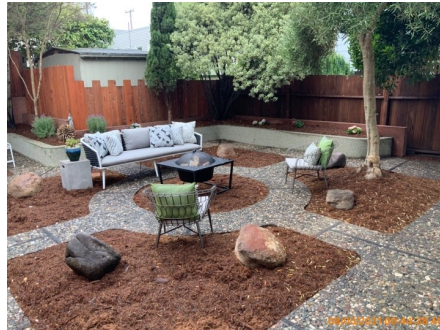
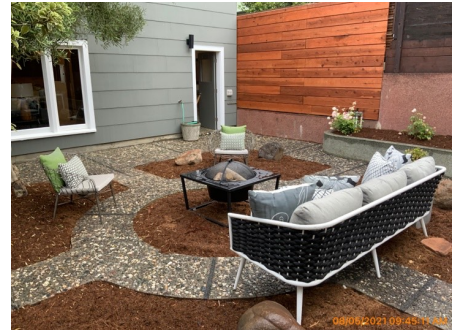
IMPROVEMENTS PATIO SURFACE

25: The patio appears to be installed in a workmanlike manner and is in good condition.

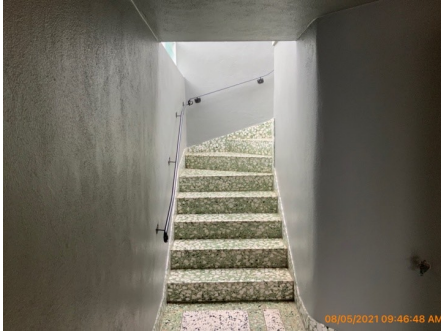
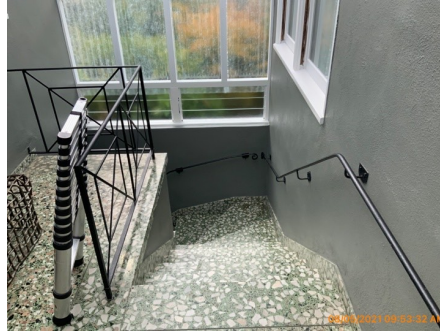
IMPROVEMENTS STAIRS

26: The exterior stairs appear to be properly constructed and are in serviceable condition with minor exceptions noted below.

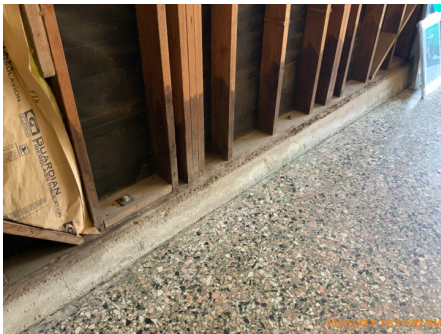
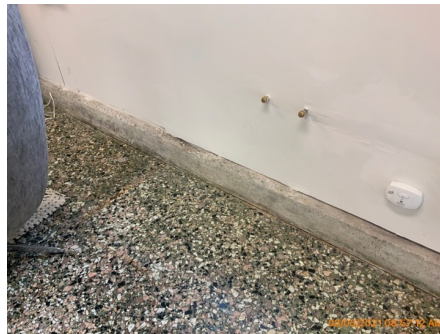
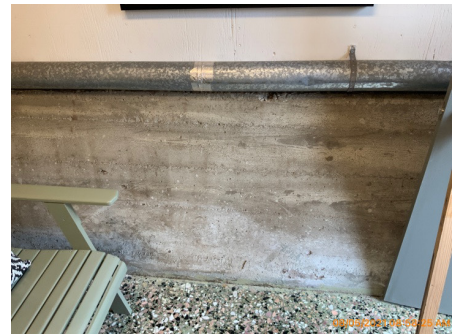
FOUNDATION BASE FOUNDATION

39: CONCRETE/BLOCK: The foundation and other visible elements of the support structure have performed well and are in good condition for the age of the structure.

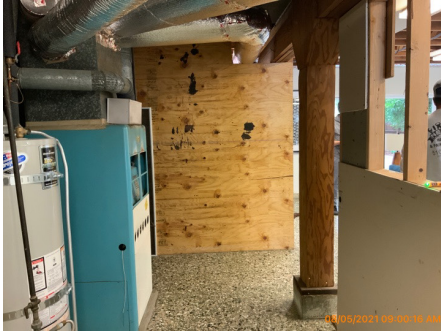
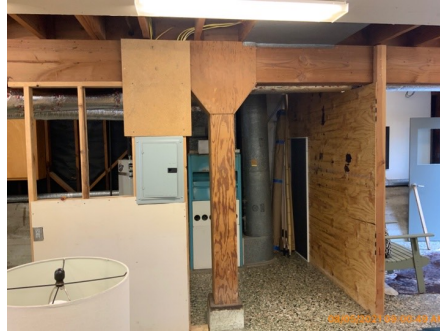
44: The floor system is supported by wooden posts set over concrete pier blocks.

45: The support posts have performed adequately over time and would be expected to continue to do so.

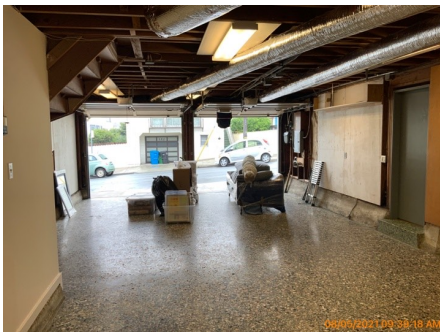
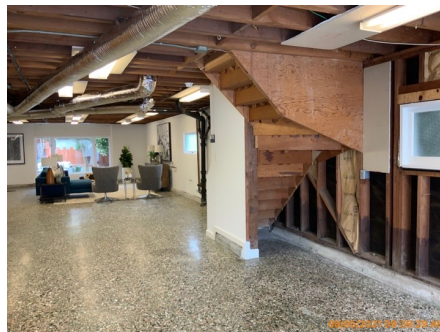
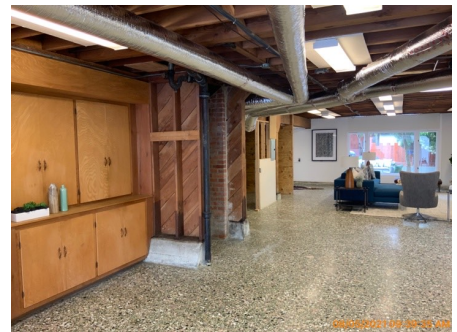
GENERAL COMMENT

58: The finished surfaces, hardware, windows, and doors were found to be generally in good condition at the time of our inspection.

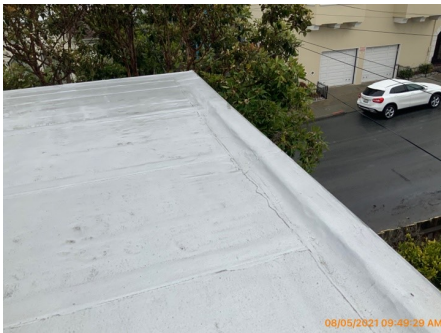
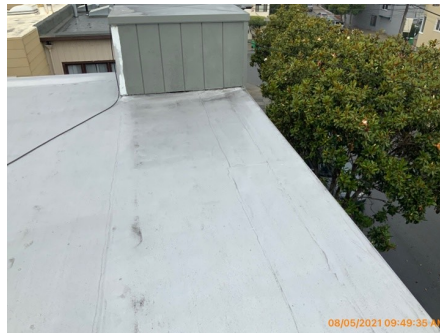
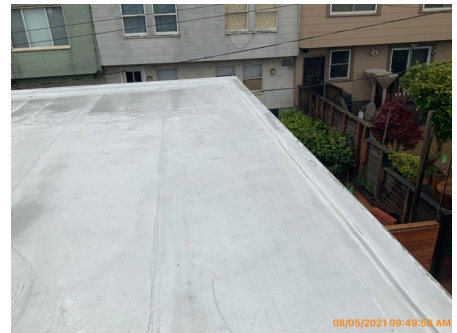
SURFACES SURFACE (BUILT-UP)

66: The roofing surface shows wear due to exposure but appears to have been properly installed and is in a condition deemed acceptable for its age. No action is indicated at this time.

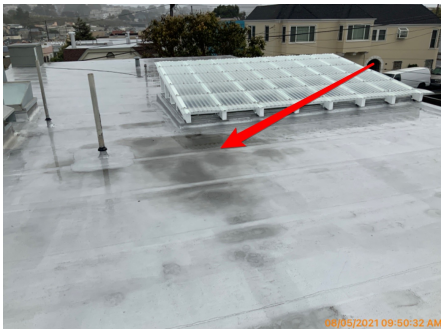
67: There is evidence of shallow ponding at the center of the roof. The presence of shallow ponds of water immediately after rains are not unusual, but regular maintenance of these areas is vital to avoid a buildup of rotting vegetation.

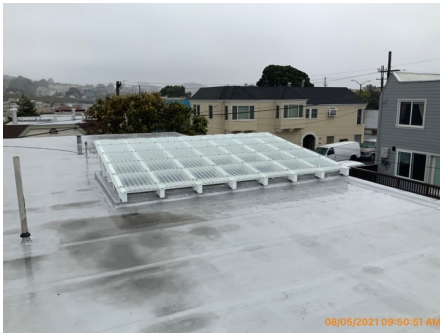
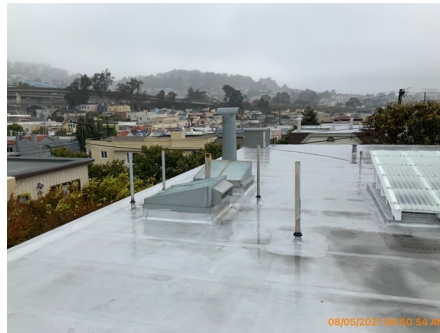
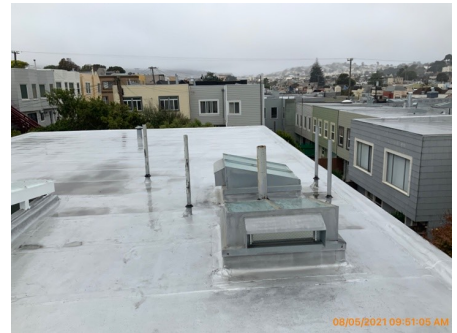
73: The roof covering appears to have been installed in a professional and workmanlike fashion. We observed no signs of unusual or excessive wear of the roofing components that would suggest immediate attention is required.

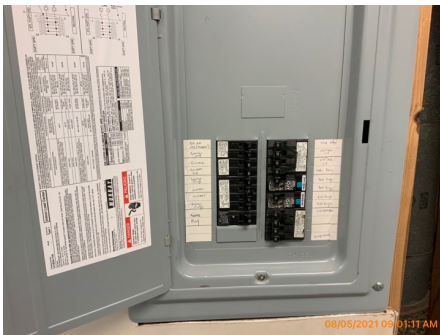
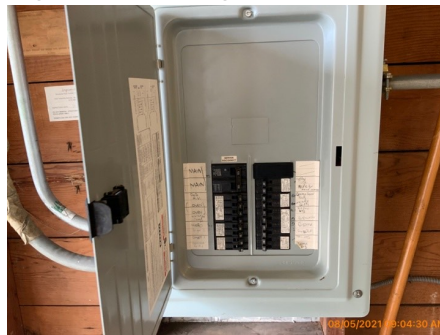
DISTRIBUTION BREAKER SUBPANEL

83: GENERAL: Additional distribution panels, or subpanels, are located in the garage.

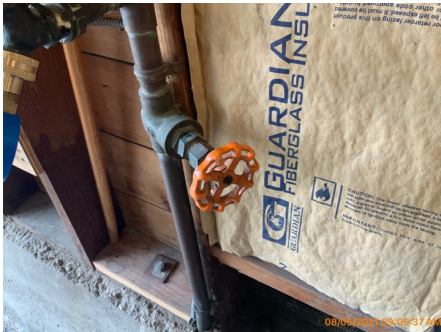
WATER SUPPLY WATER SHUTOFF LOCATION

- 99:** The domestic water supply shut-off valve is in the garage.

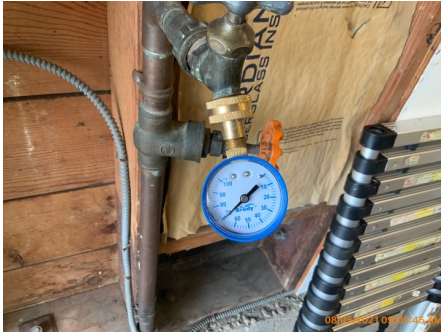
WATER SUPPLY WATER PRESSURE

102: The system water pressure, as measured at the exterior hose bibs, is within the range of normal.

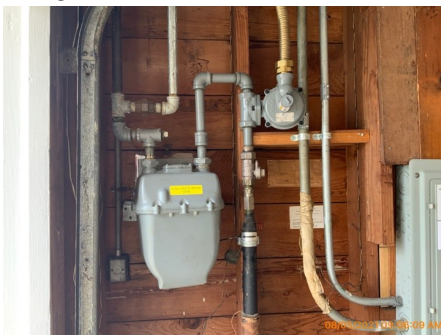
GAS SYSTEM GAS METER LOCATION

107: The gas meter is in the garage. The main gas supply shutoff valve is located on the riser pipe between the slab and the meter. This valve should be turned 90 degrees (either way) in order to shut off the gas.

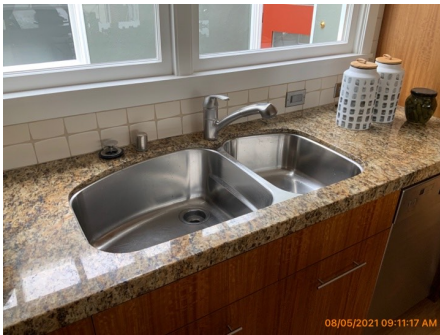
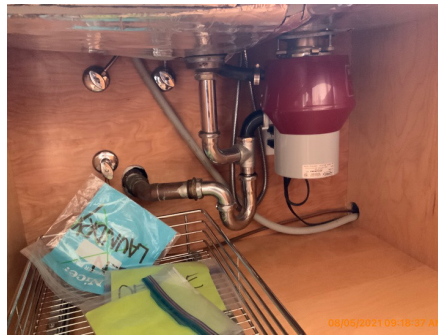
PLUMBING SINK

135: The sink appears to be properly installed. When operated, it was observed to be fully functional and in serviceable condition.

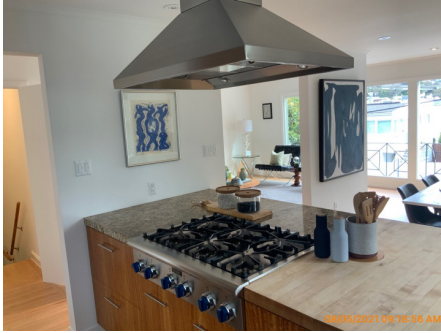
APPLIANCES STOVE

144: GENERAL: The stove was turned on with the normal operating controls and found to be in satisfactory working condition.

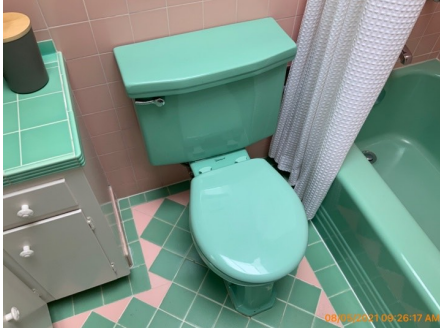
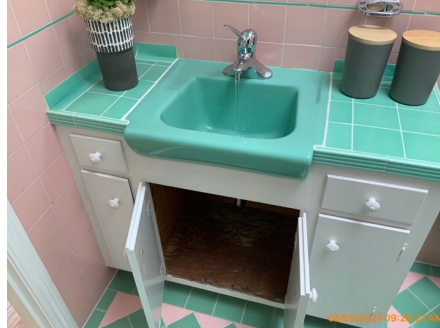
PLUMBING TOILET

164: The toilet was flushed and appeared to be functioning properly.

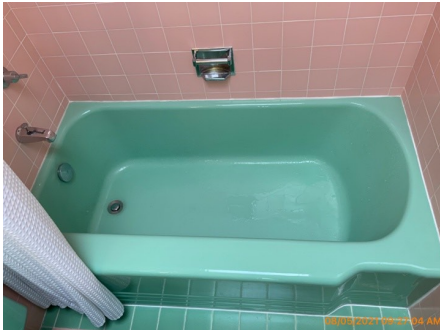
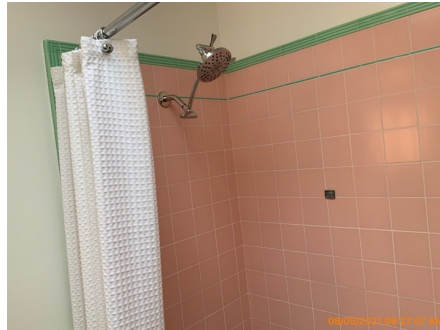
PLUMBING BATHTUB

166: The bathtub appears to be properly installed and in serviceable condition.

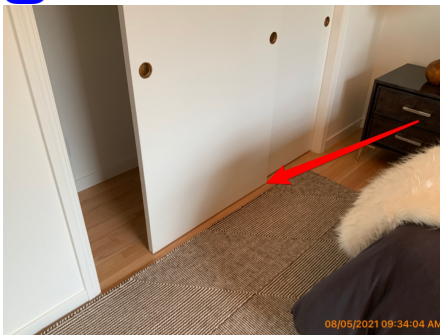
DOORS & WINDOWS CLOSET DOORS

178: The bottom glide/track on the closet door(s) are missing.

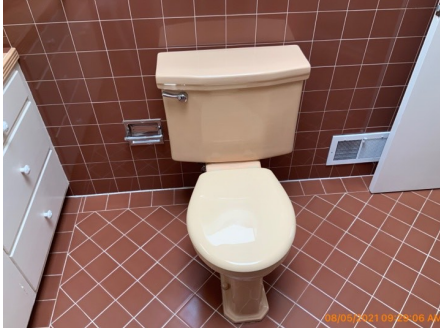
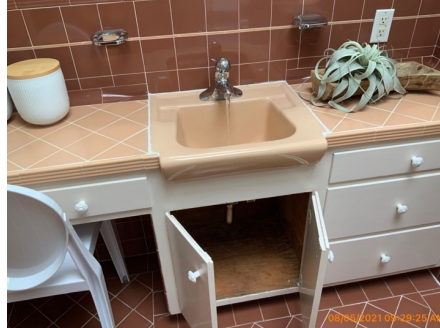
PLUMBING TOILET

184: The toilet was flushed and appeared to be functioning properly.

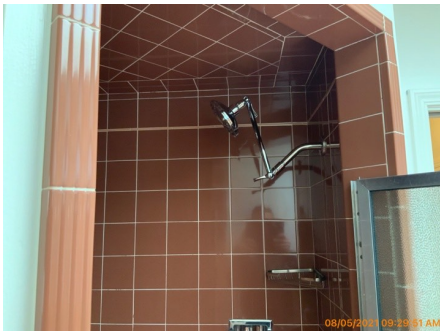
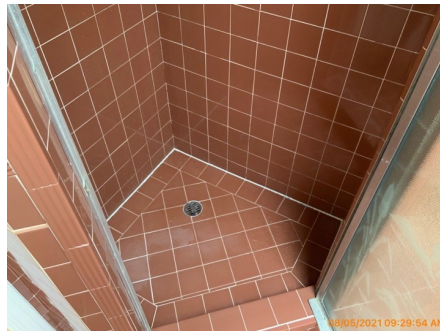
PLUMBING SHOWER

186: SHOWER: The shower was operated for the inspection and appeared to be in serviceable condition.

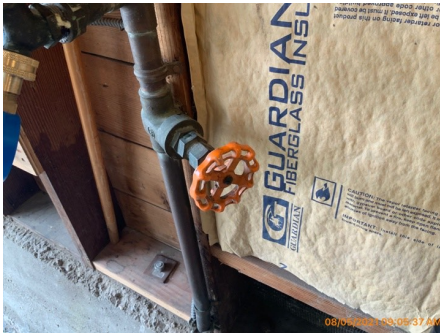
2: The domestic water supply shut-off valve is in the garage.

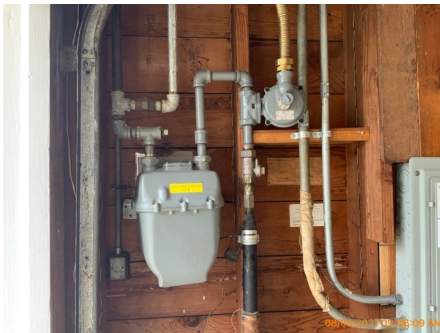
GAS SYSTEM GAS METER LOCATION

3: The gas meter is in the garage. The main gas supply shutoff valve is located on the riser pipe between the slab and the meter. This valve should be turned 90 degrees (either way) in order to shut off the gas.
