Confidential Inspection Report

LOCATED AT:
Sample Street
San Francisco, California

INSPECTED ON:
Tuesday, September 21, 2021

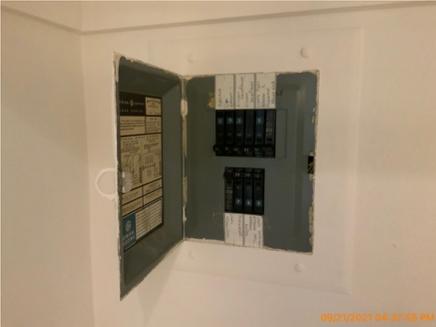
- 16: GENERAL:** An additional distribution panel, or subpanel, is located in the secondary bedroom closet

- 17: GENERAL:** The subpanel was opened and the inspected circuitry was generally found to be installed and fused correctly, with exceptions noted below.

- 18: GENERAL:** The panel is located in a closet, which is prohibited for present installations. To reduce the hazards of fire and allow access, we recommend clearance be maintained and relocation be considered.

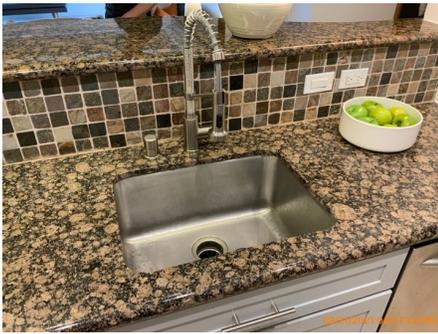
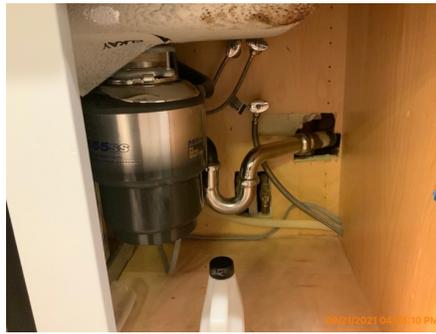
48: The dishwasher drain is equipped with an air-gap fitting (the cylinder protruding above the sink). This assures separation of the supply water from the waste water.

49: The sink appears to be properly installed. When operated, it was observed to be fully functional and in serviceable condition.

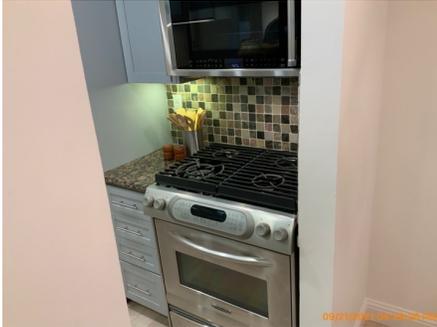
55: GENERAL: The stove was turned on with the normal operating controls and found to be in satisfactory working condition.

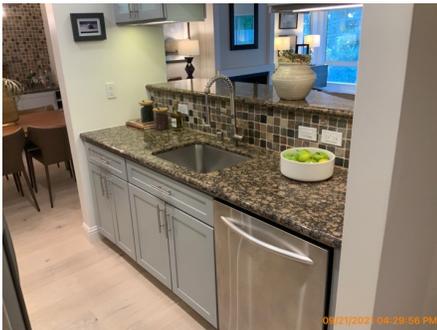
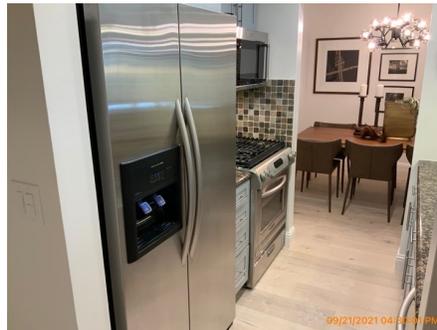
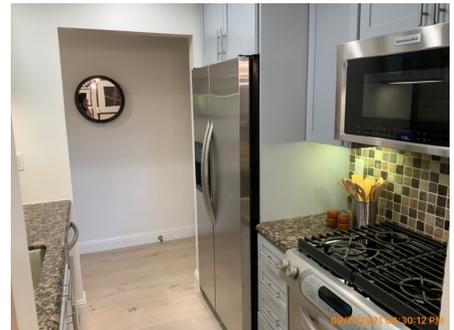
59: The finished surfaces, hardware and doors were found to be generally in good condition at the time of our inspection.

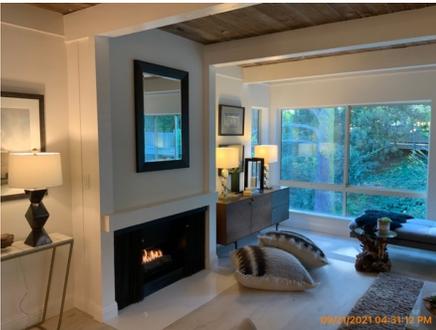
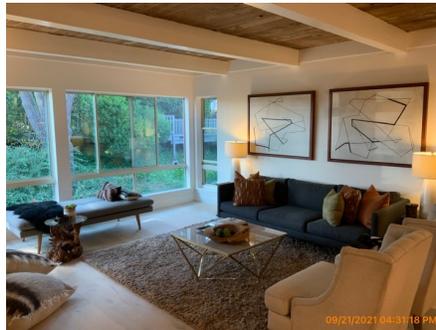
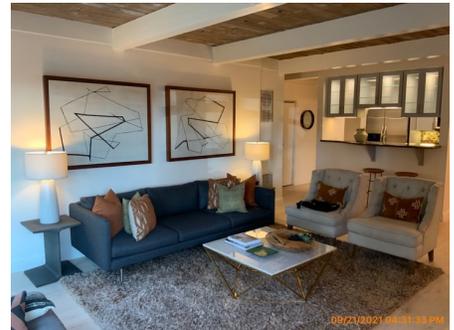
64: The finished surfaces, hardware, windows, and doors were found to be generally in good condition at the time of our inspection.

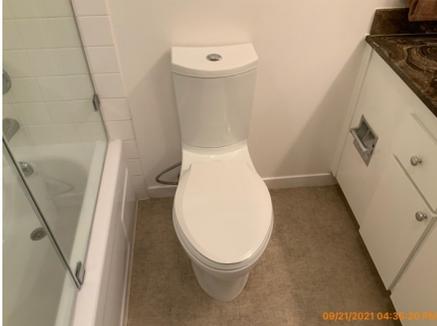
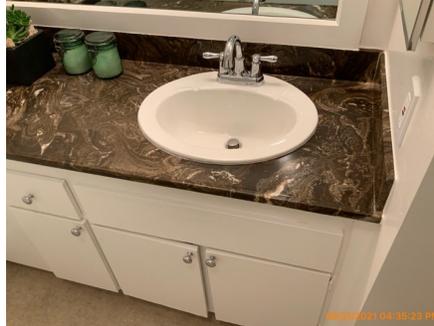
65: The toilet was flushed and appeared to be functioning properly.

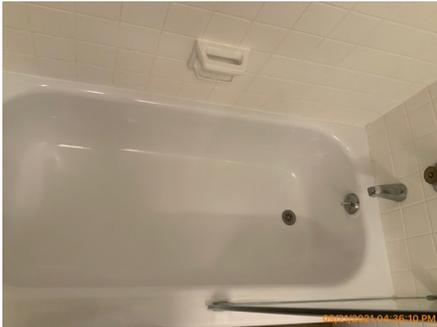
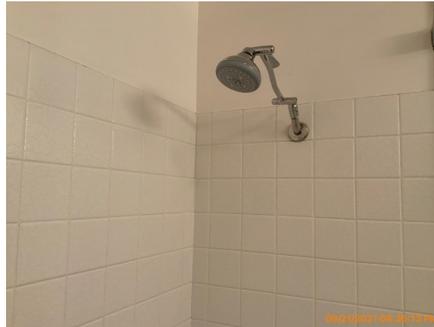
66: The wash basin appears to be properly installed. When operated, it was observed to be fully functional and in serviceable condition.

67: The bathtub appears to be properly installed and in serviceable condition.

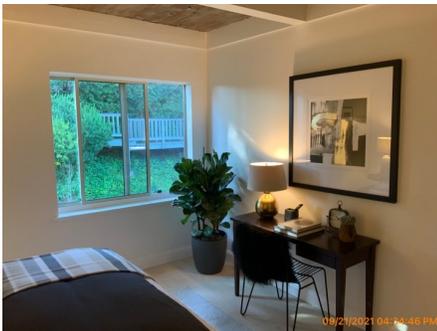
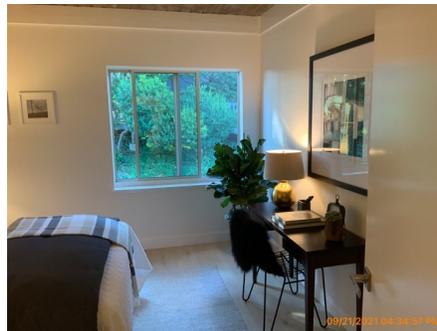
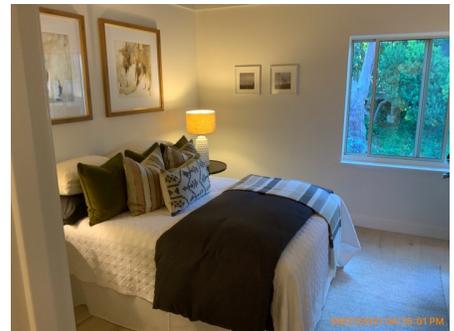
81: The finished surfaces, hardware, windows, and doors were found to be generally in good condition at the time of our inspection.

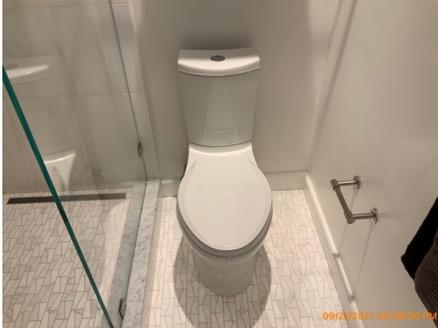
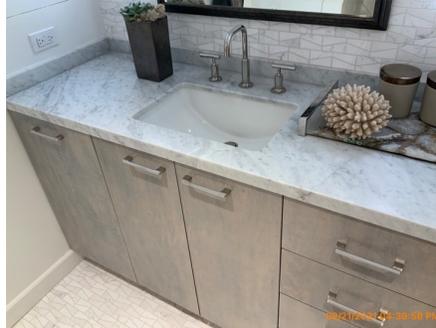
82: The toilet was flushed and appeared to be functioning properly.

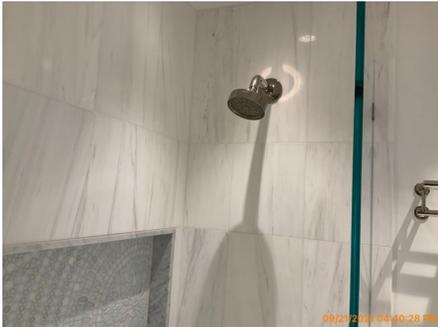
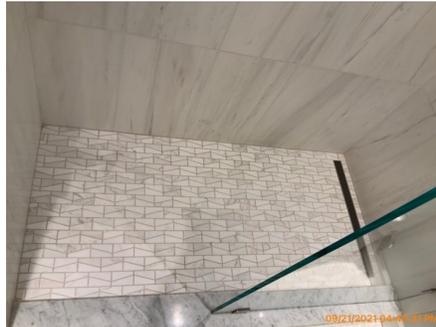
83: The wash basin appears to be properly installed. When operated, it was observed to be fully functional and in serviceable condition.

84: SHOWER: The shower was operated for the inspection and appeared to be in serviceable condition.

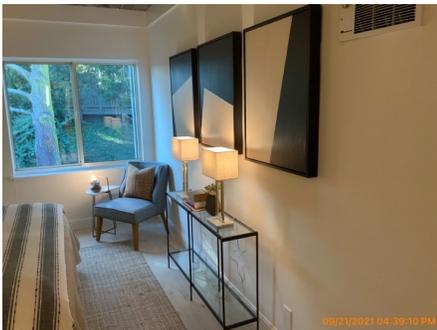
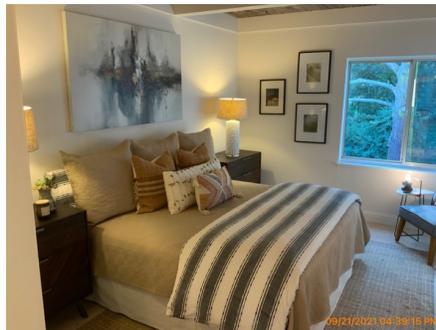
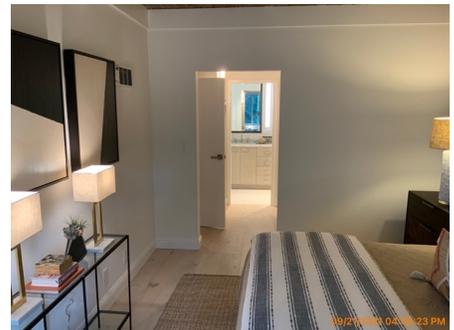
96: The finished surfaces, hardware, windows, and doors were found to be generally in good condition at the time of our inspection.
