Confidential Inspection Report

LOCATED AT:
Sample Street
San Francisco, California 94112

INSPECTED ON:
Thursday, August 5, 2021

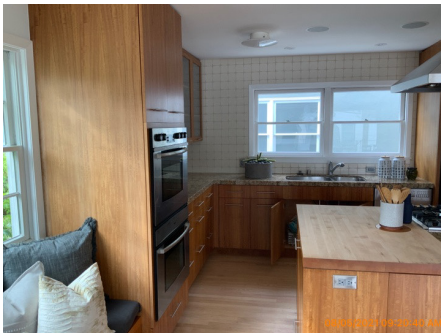
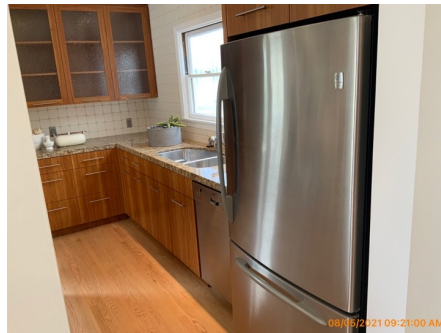
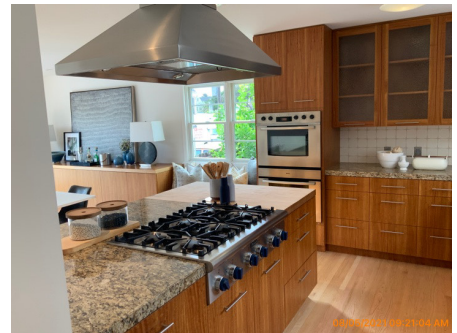
148: The finished surfaces, hardware, windows, and doors were found to be generally in good condition at the time of our inspection.

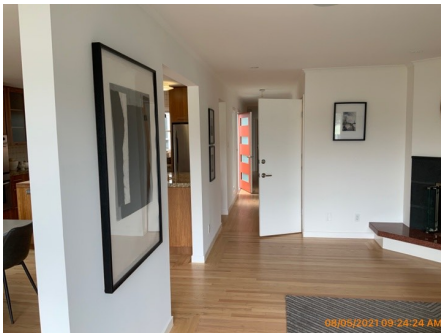
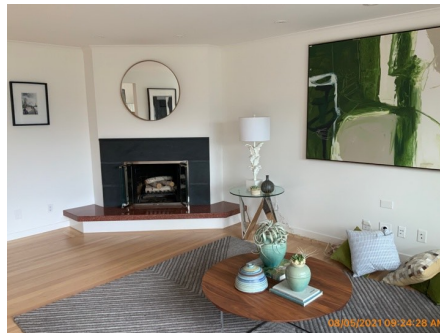
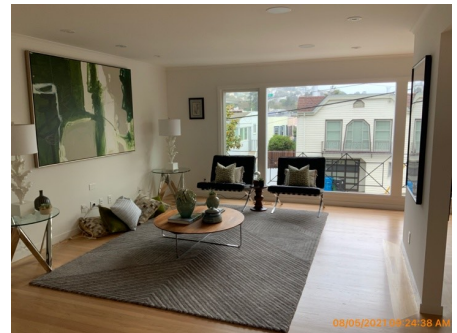
154: The finished surfaces, hardware, windows, and doors were found to be generally in good condition at the time of our inspection.

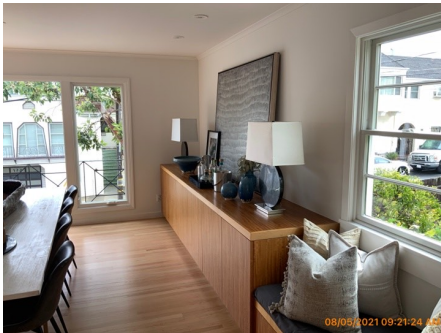
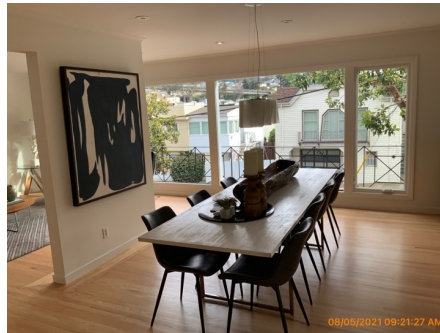
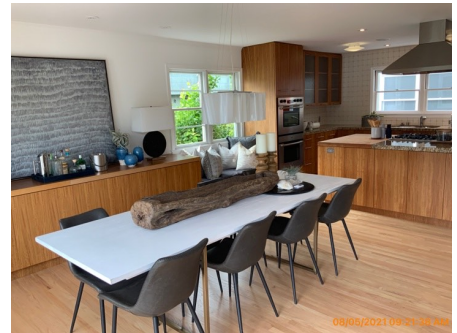
157: The finished surfaces, hardware, windows, and doors were found to be generally in good condition at the time of our inspection.

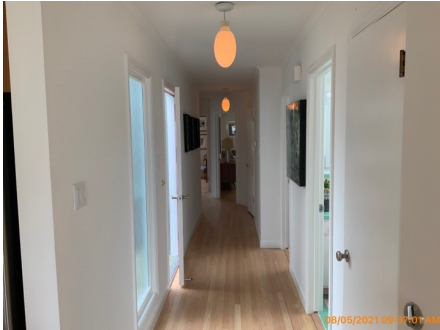
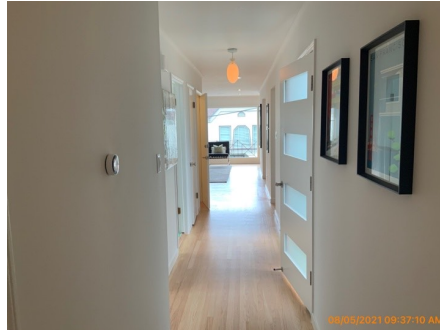
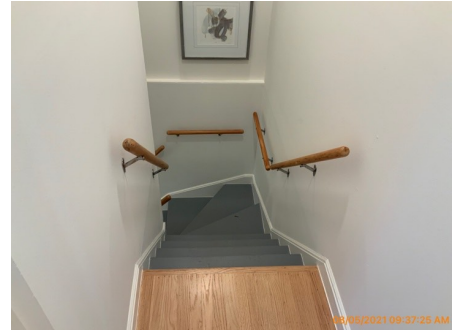
163: The finished surfaces, hardware, windows, and doors were found to be generally in good condition at the time of our inspection.

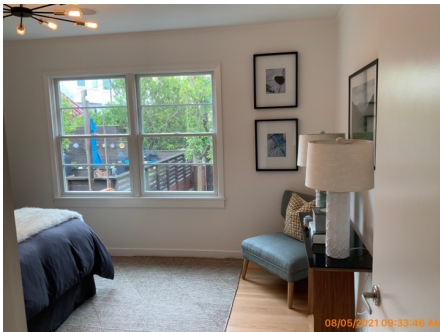
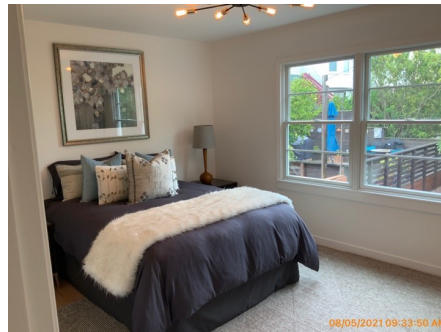
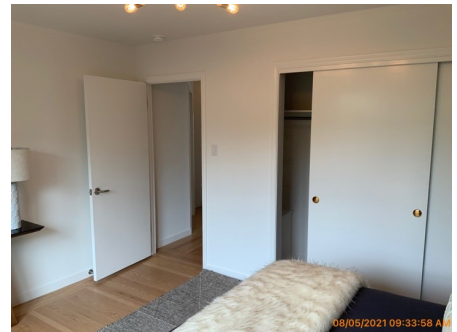
179: The finished surfaces, hardware, windows, and doors were found to be generally in good condition at the time of our inspection.

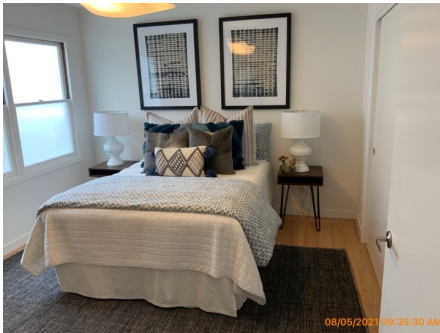
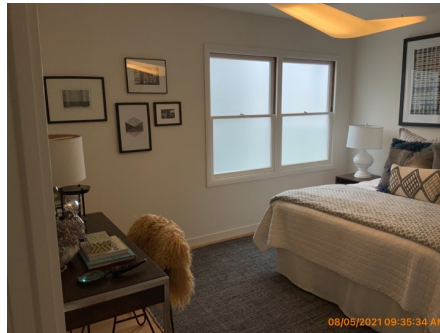
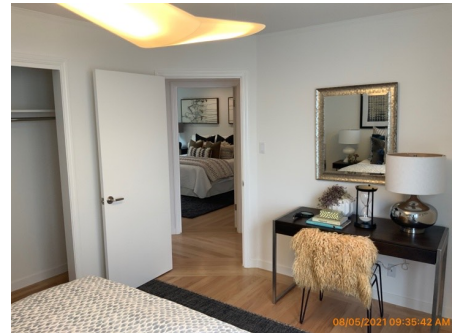
183: The finished surfaces, hardware, windows, and doors were found to be generally in good condition at the time of our inspection.

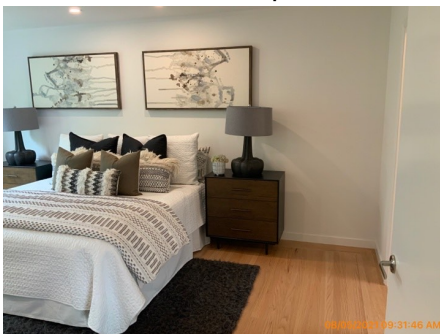
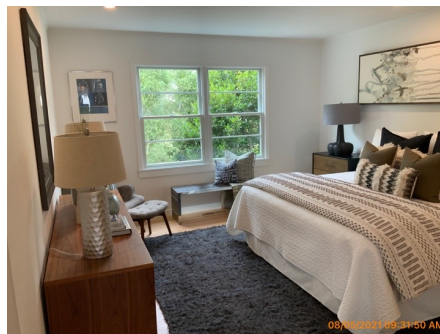
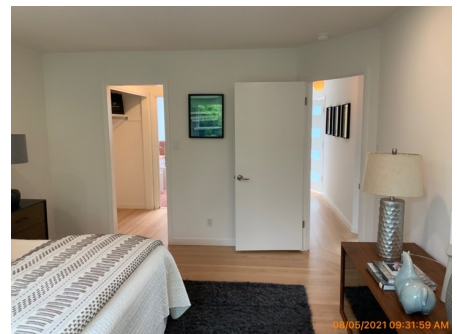
199: The finished surfaces, hardware, windows, and doors were found to be generally in good condition at the time of our inspection.
